PRENDOS Limited

# **RISK EVALUATION**

# **BUILDING WEATHERTIGHTNESS**

# **Pilot Study of Weathertightness Failures**

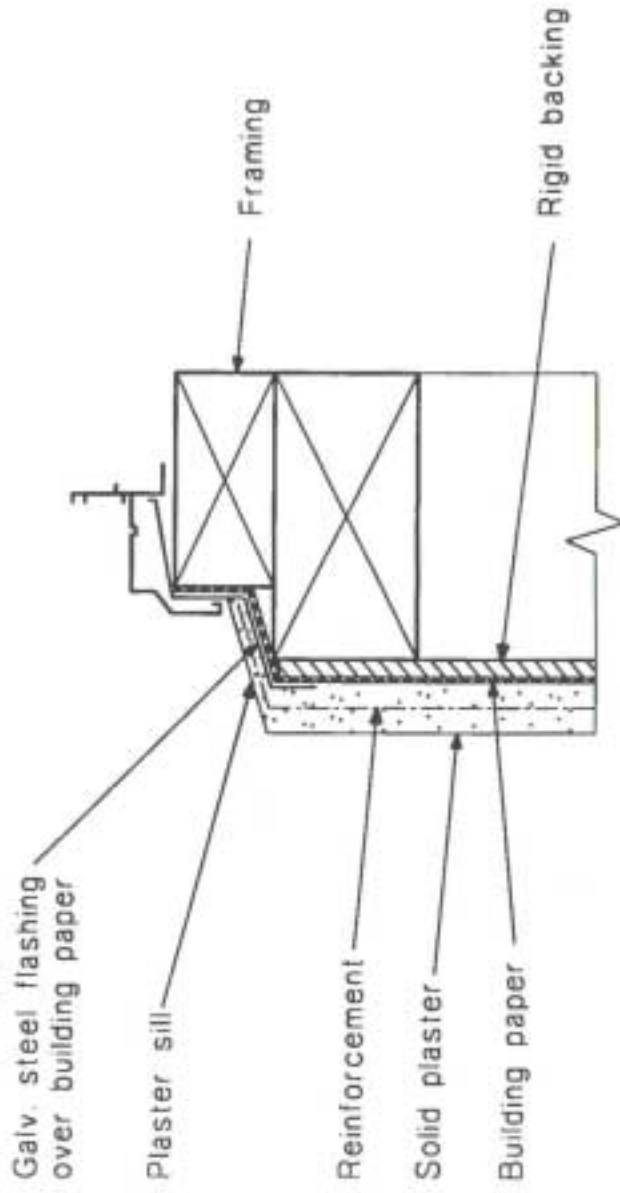
**Figure 1(c) – Alternative sill detail**

**NZS 4251:Part 1:1998**

NOTE -  
Intermediate solid plaster coats  
not shown for clarity.

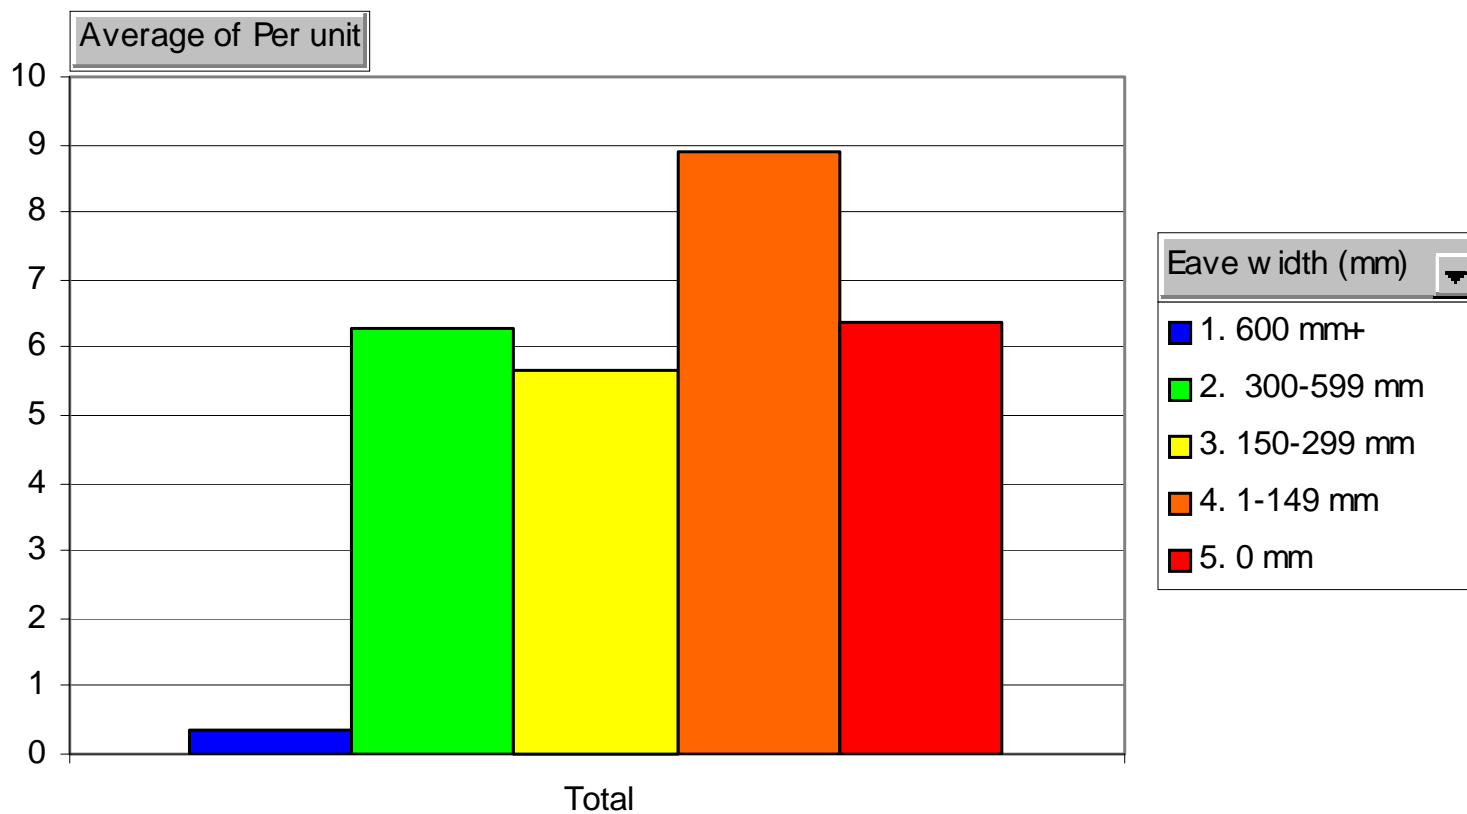
# Roof Eave Width vs Wall Leaks Per Unit

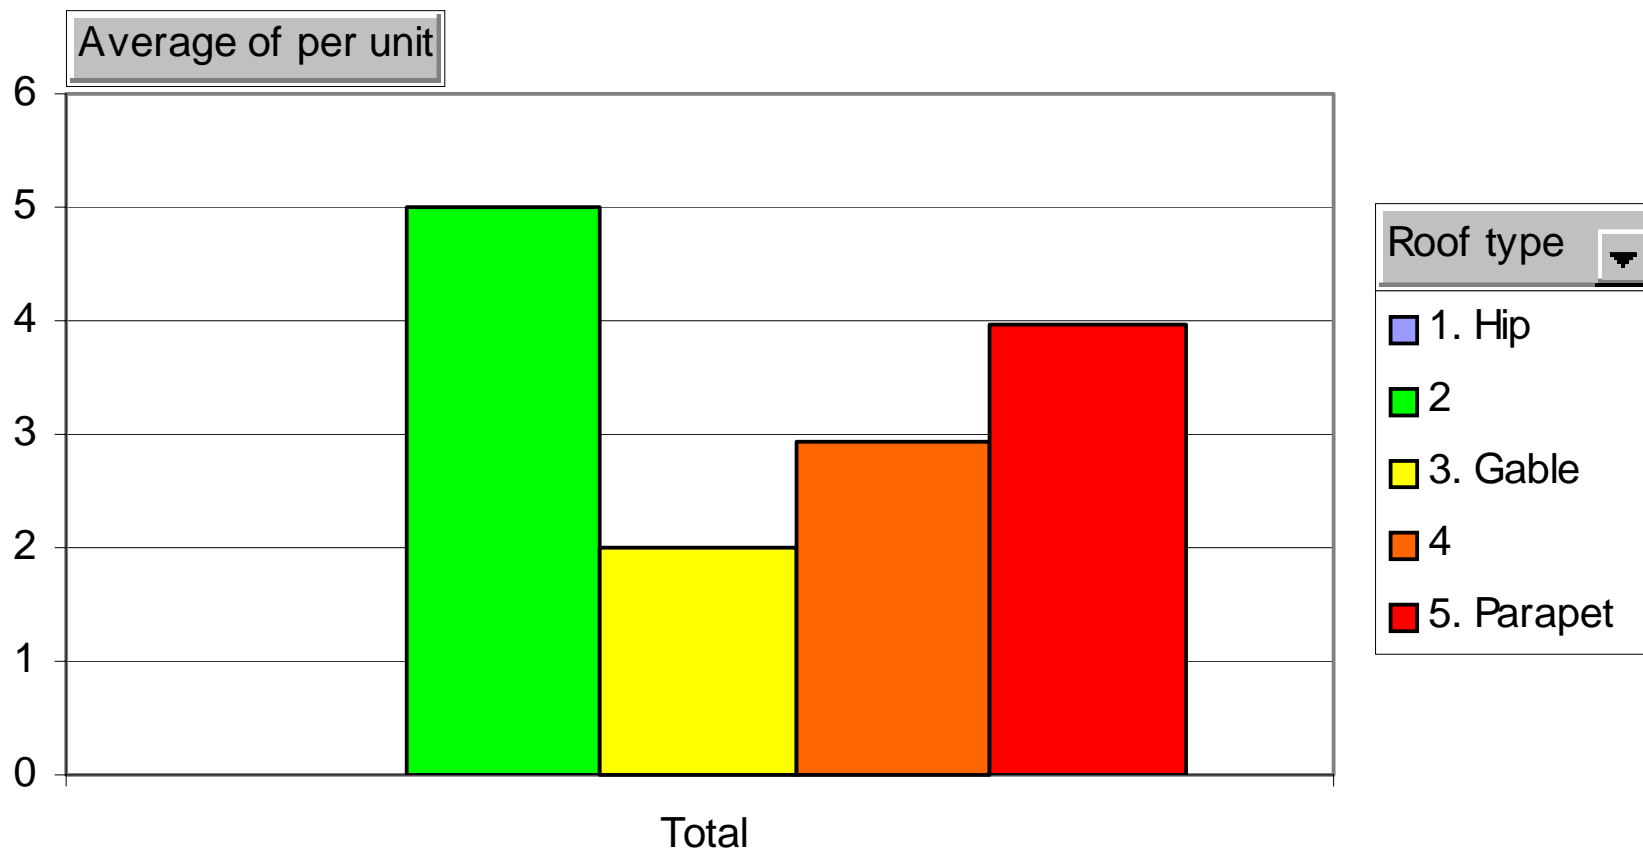
# Roof Type vs Wall Leaks Per Unit

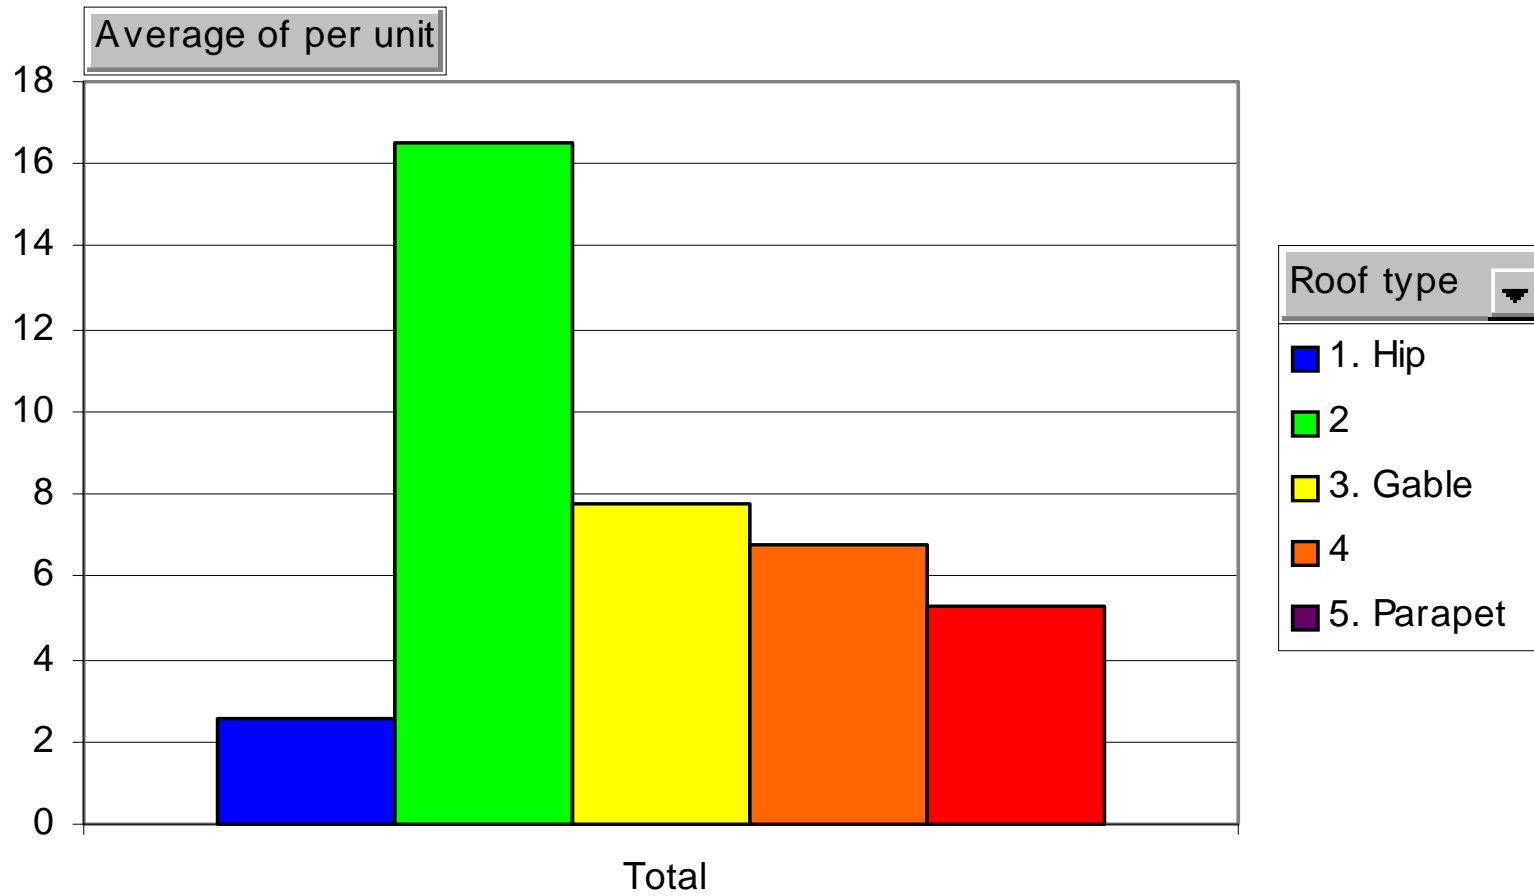
# Roof Type vs Leaks Per Unit

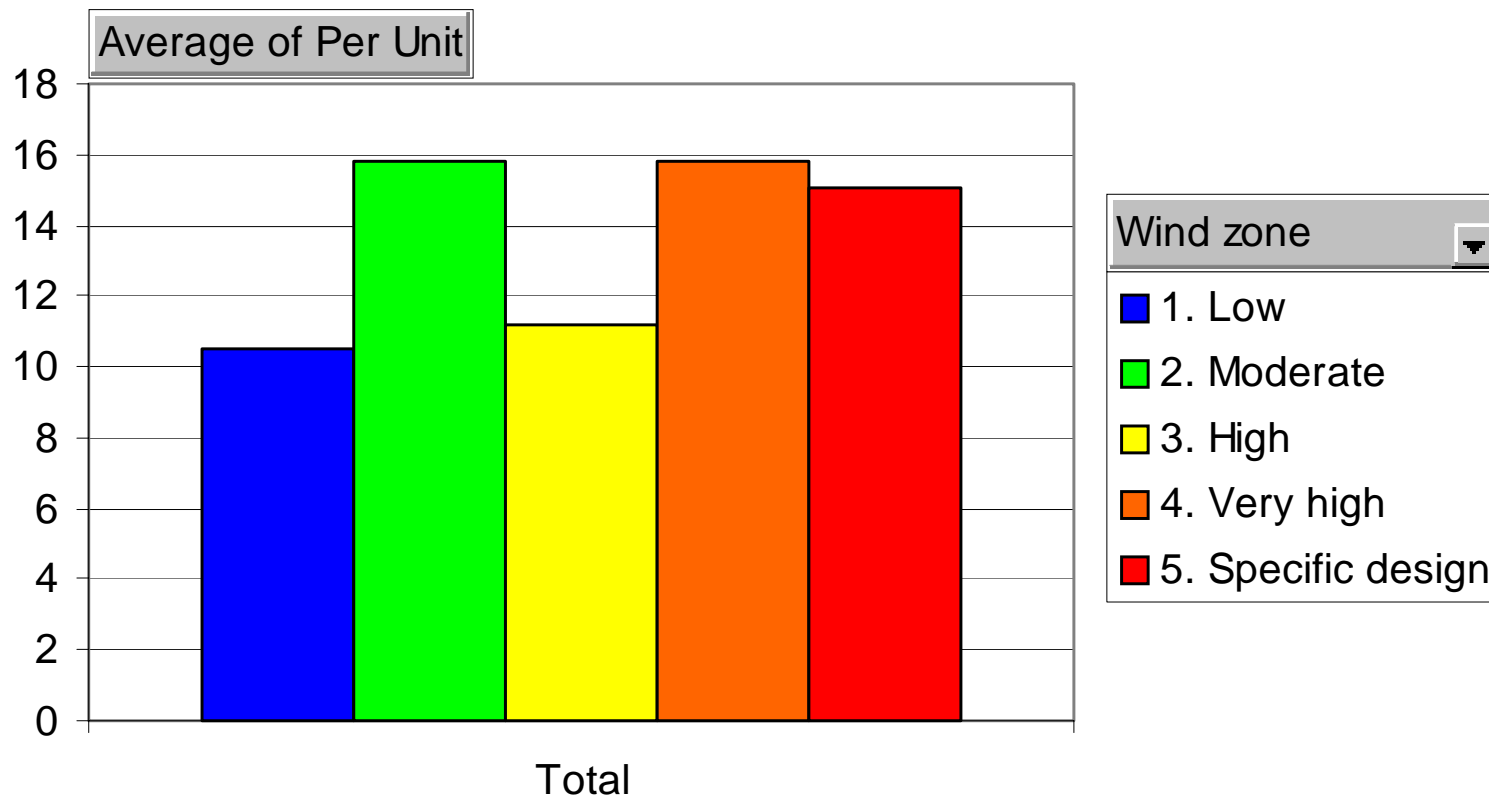
# Wind Zone vs Wall, Roof and Balcony Leaks Per Unit

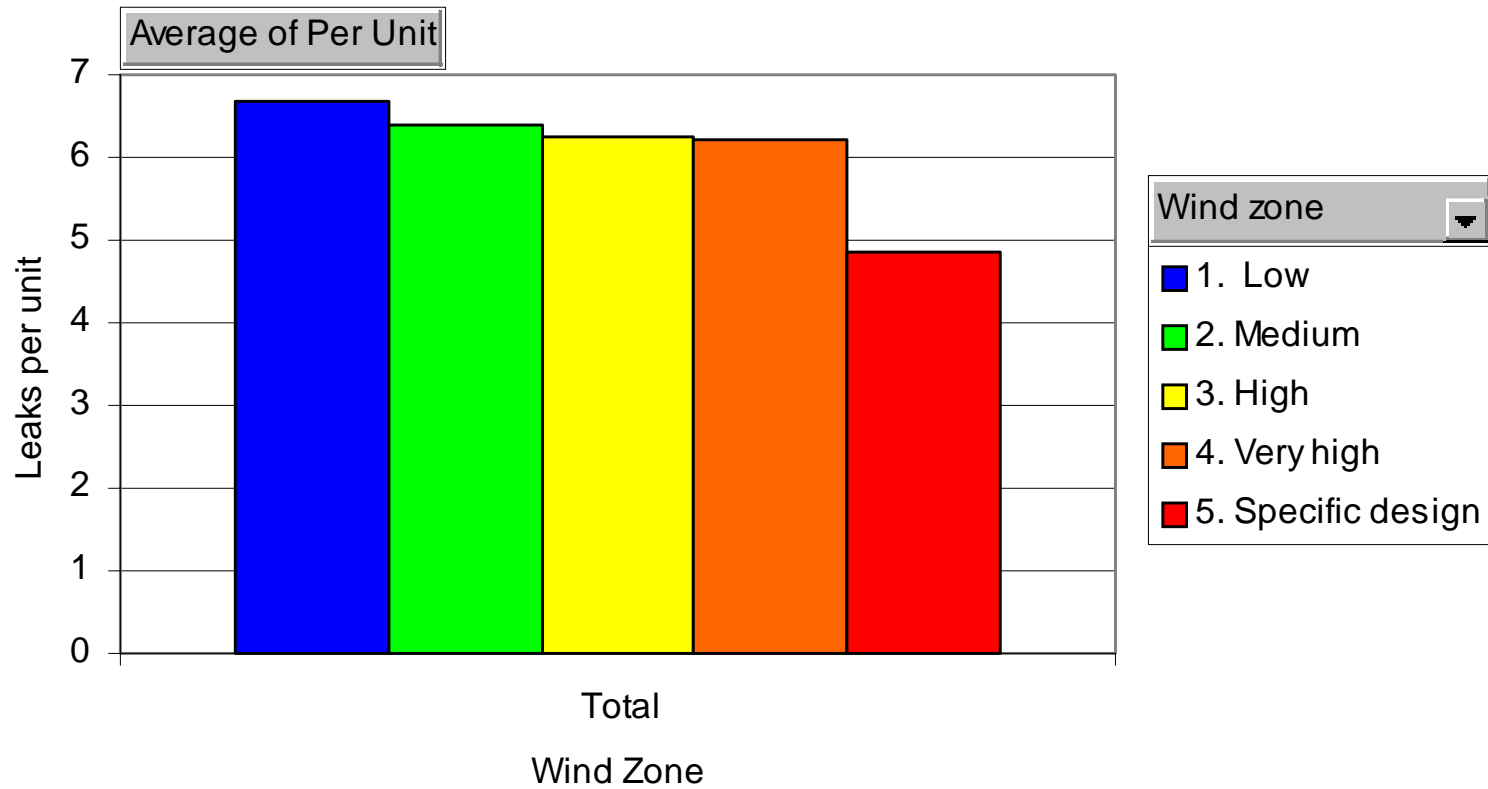
# Wind Zone vs Wall Leaks Per Unit

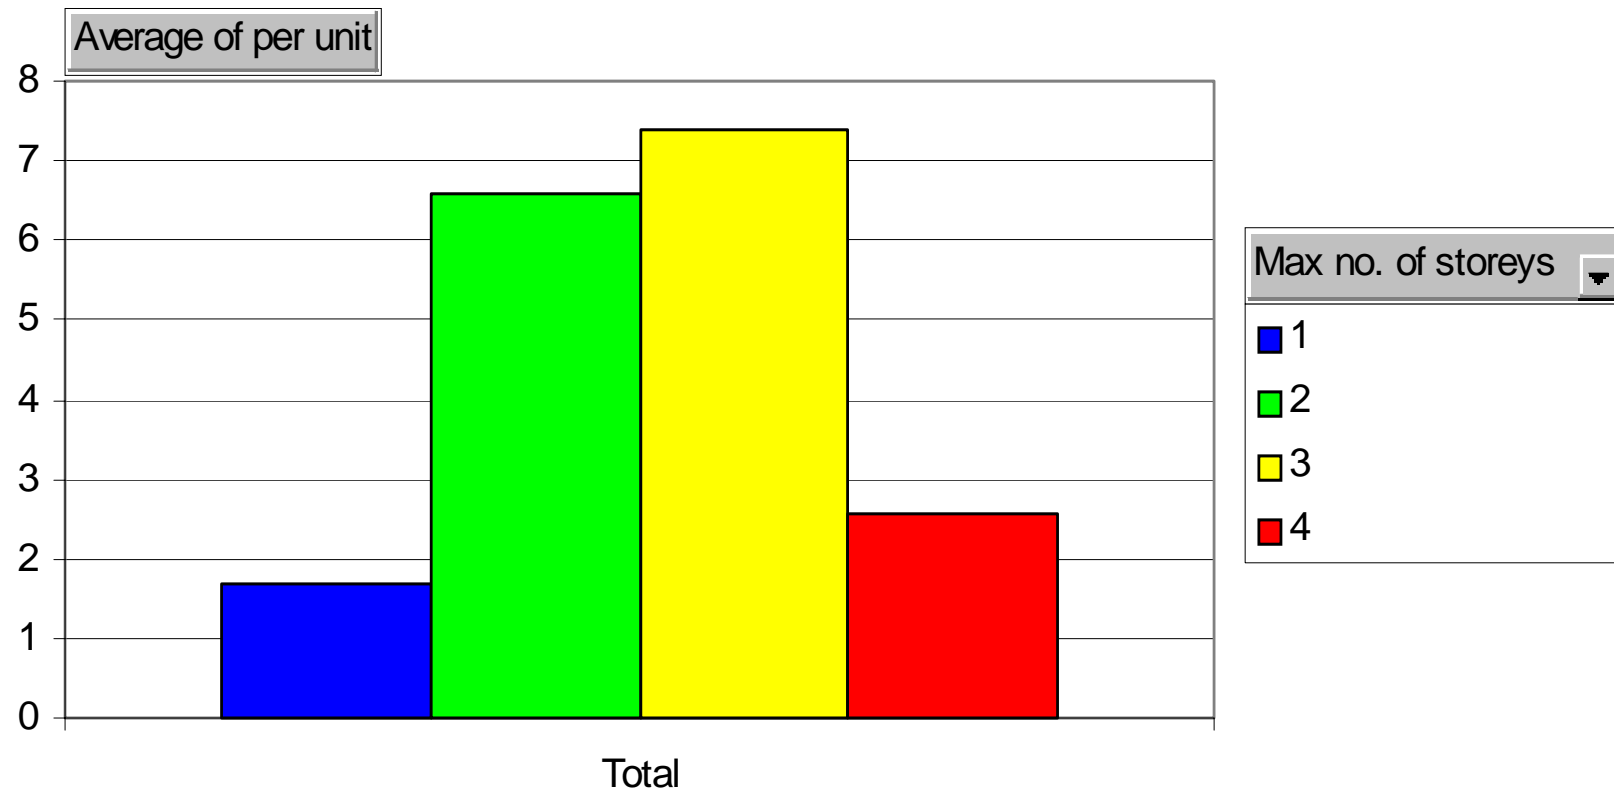
# No. of Storeys vs Wall Leaks Per Unit

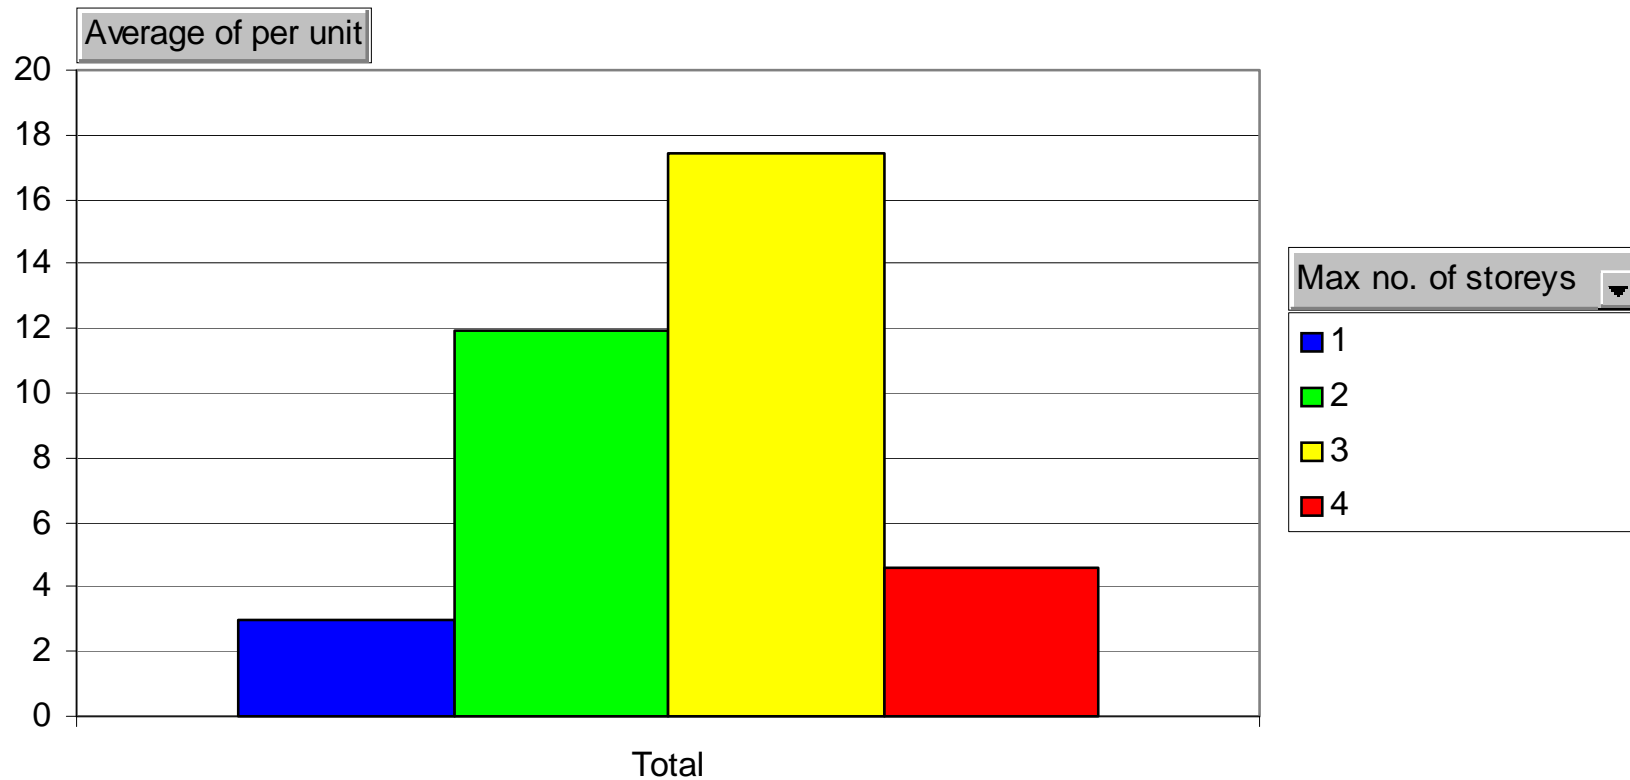
# No. of Storeys vs Roof, Balcony and Wall Leaks Per Unit

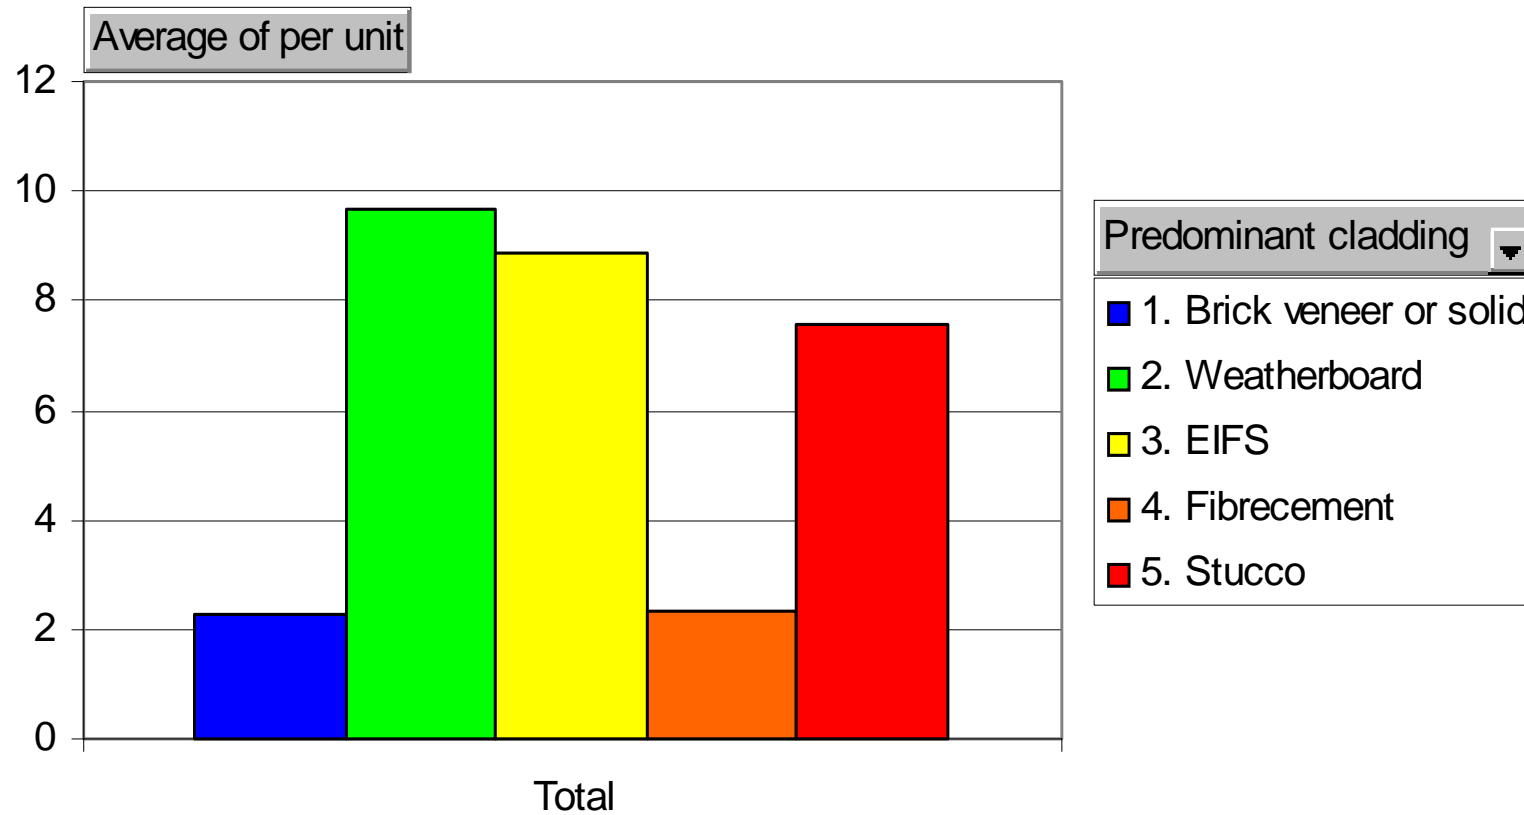
# Predominant Cladding vs Wall Leaks Per Unit

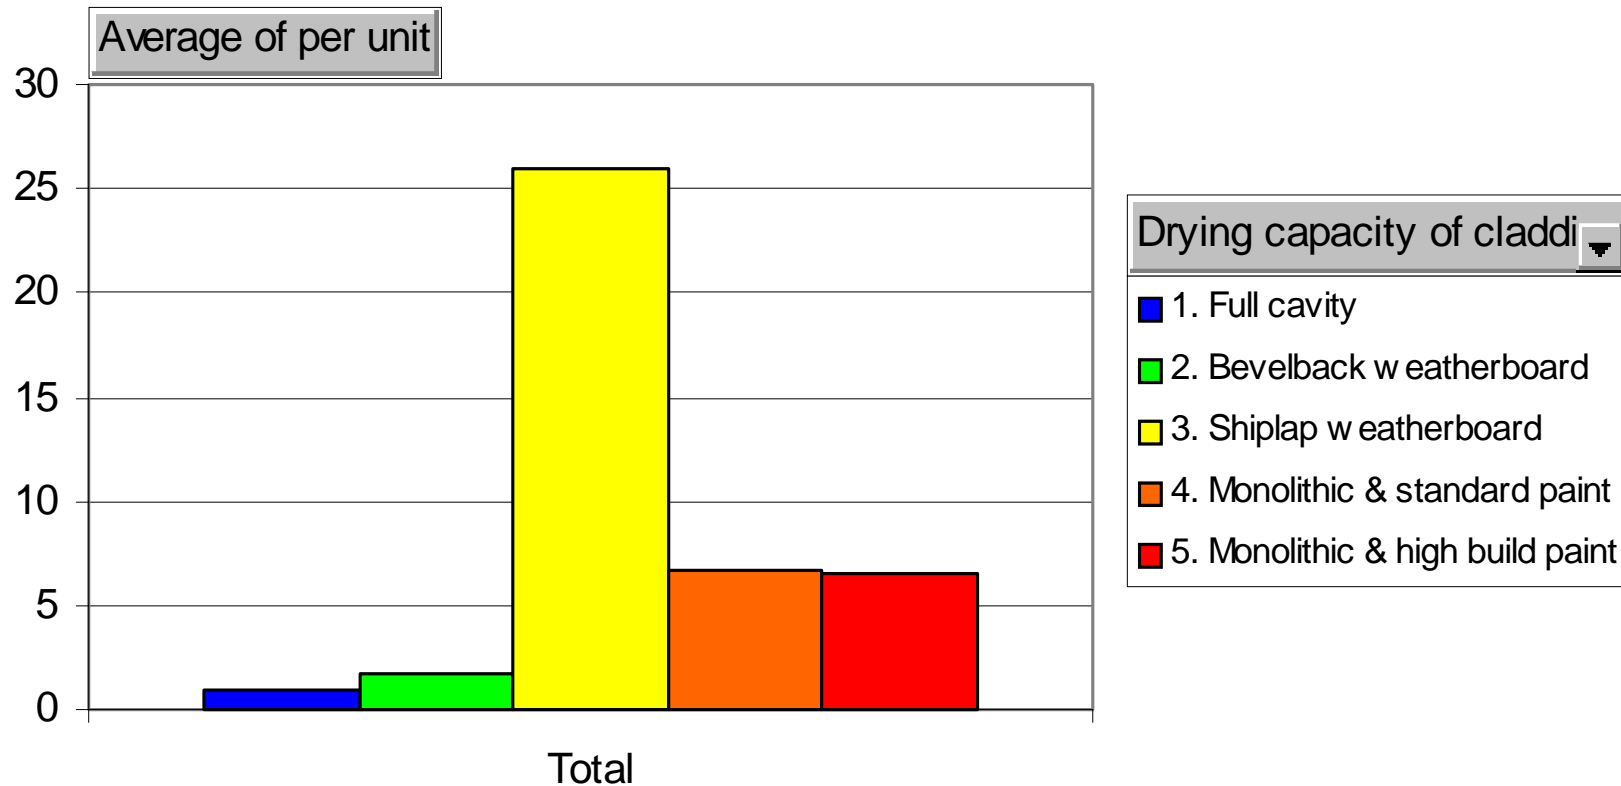
# Cladding Drying Capacity vs Wall Leaks Per Unit

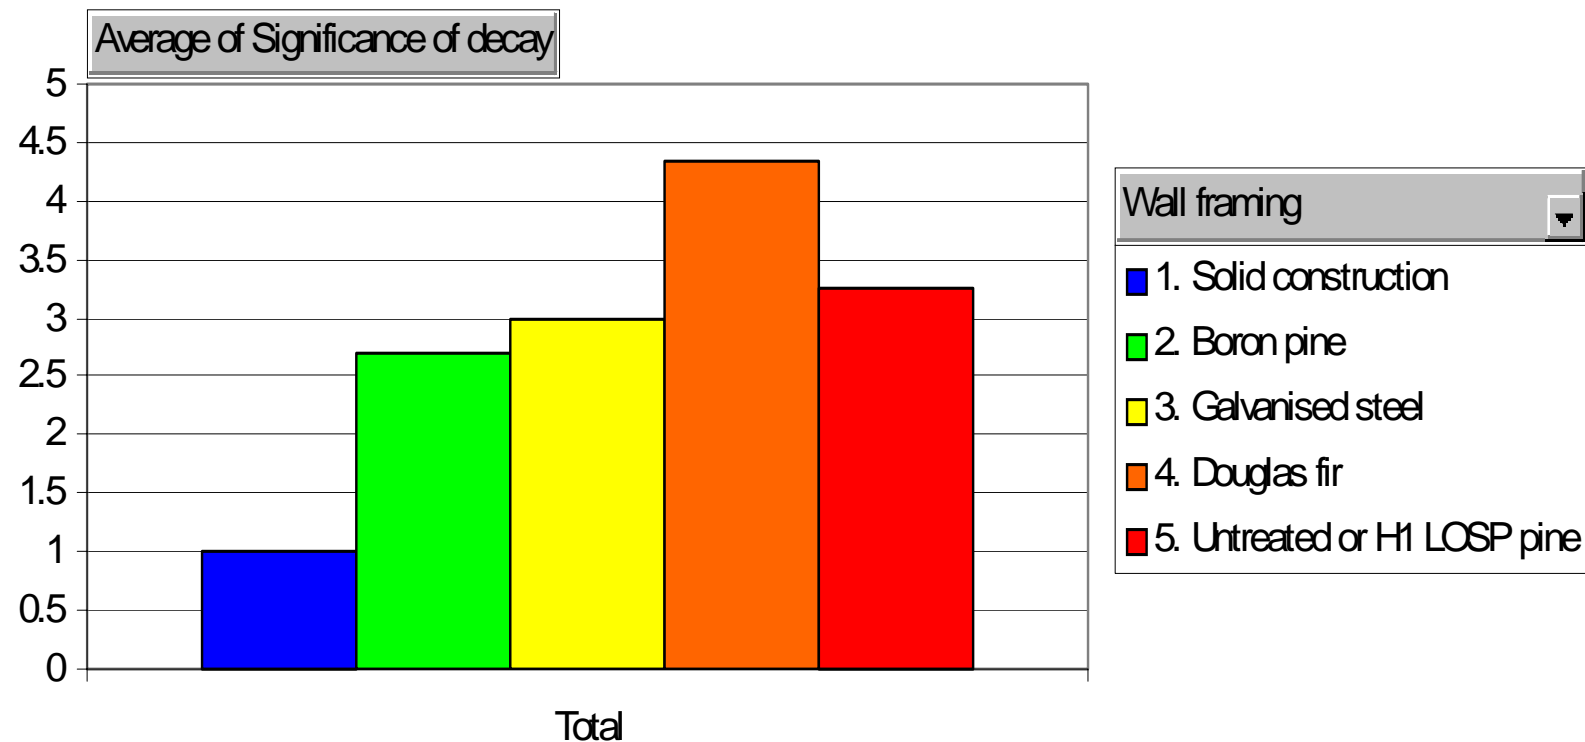
# Framing vs Significance of Corrosion Decay (Average)

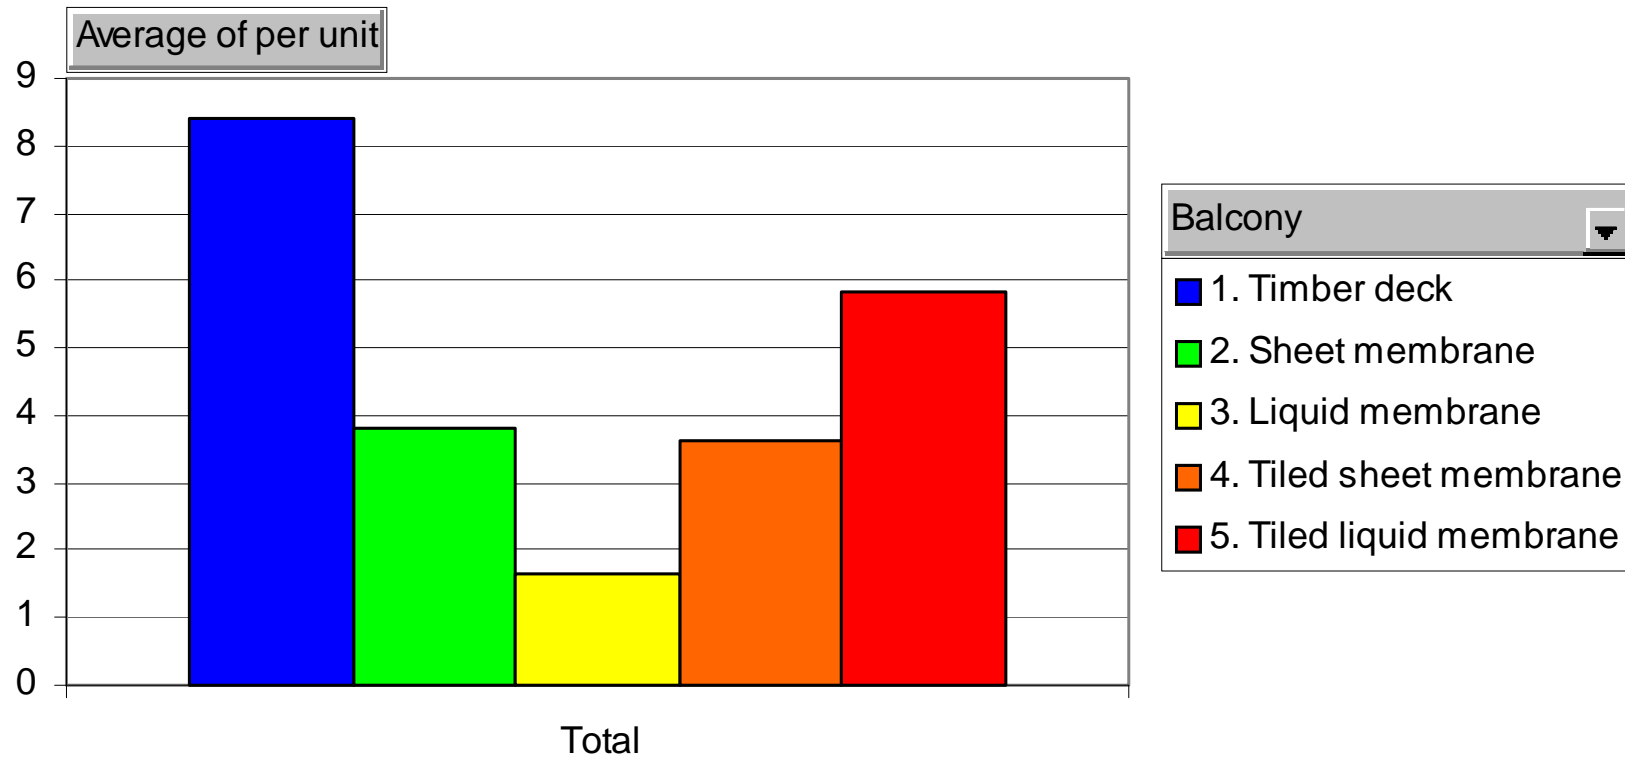
# Balcony vs Balcony Leaks Per Unit

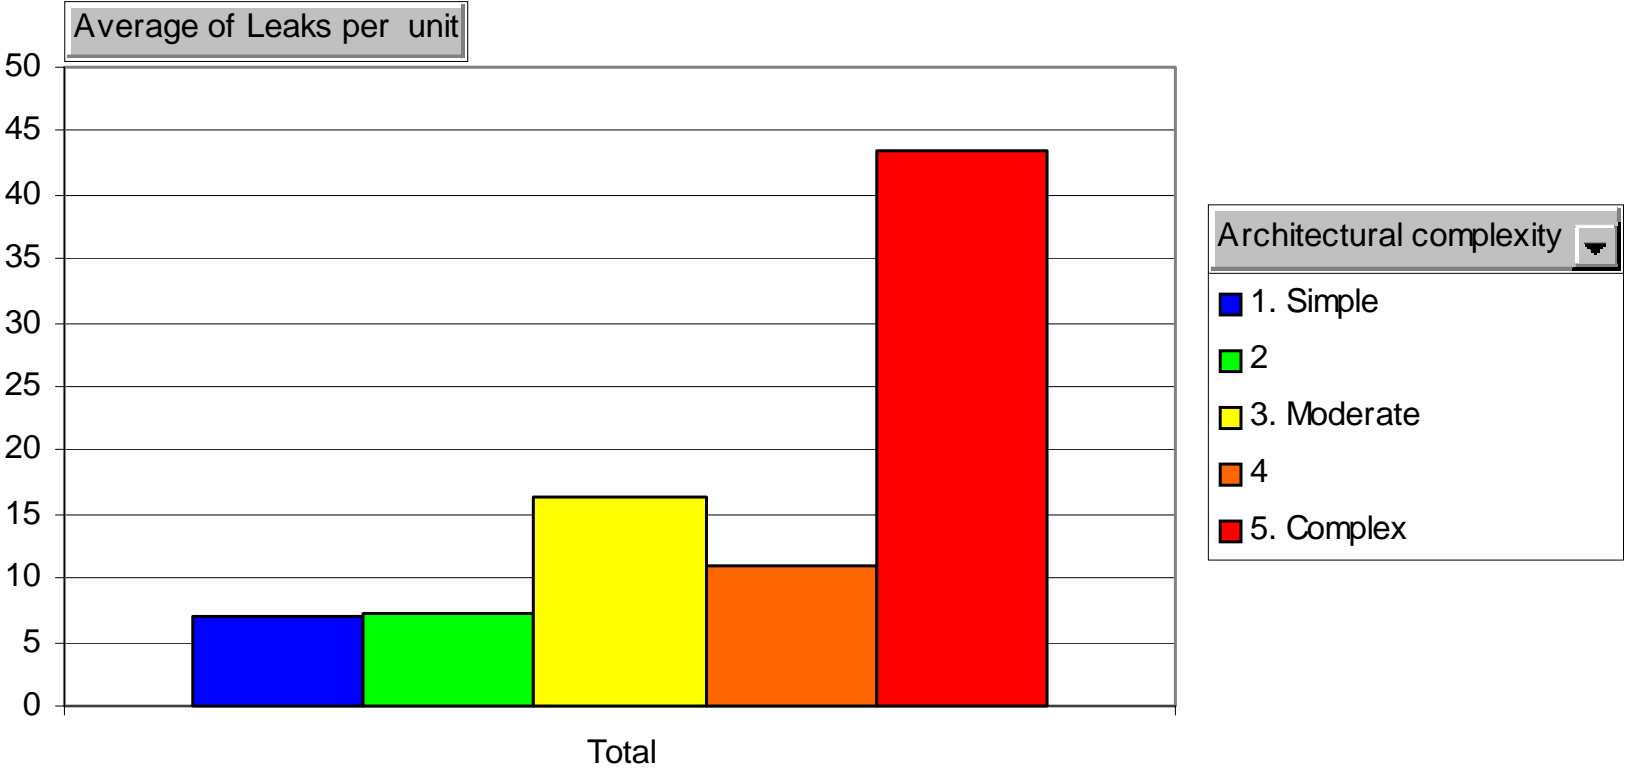
# Architectural Complexity vs Leaks Per Unit

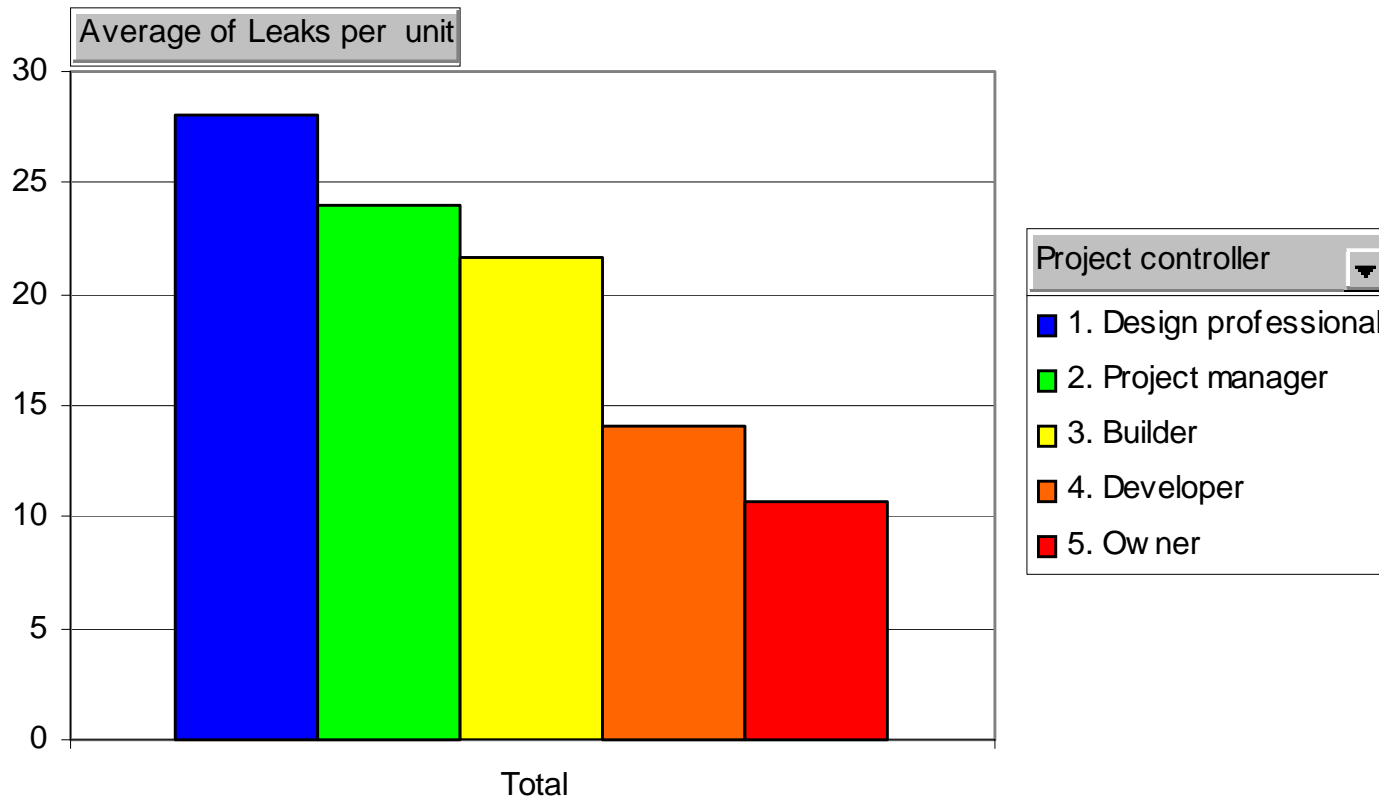
# Project Controller vs Leaks Per Unit

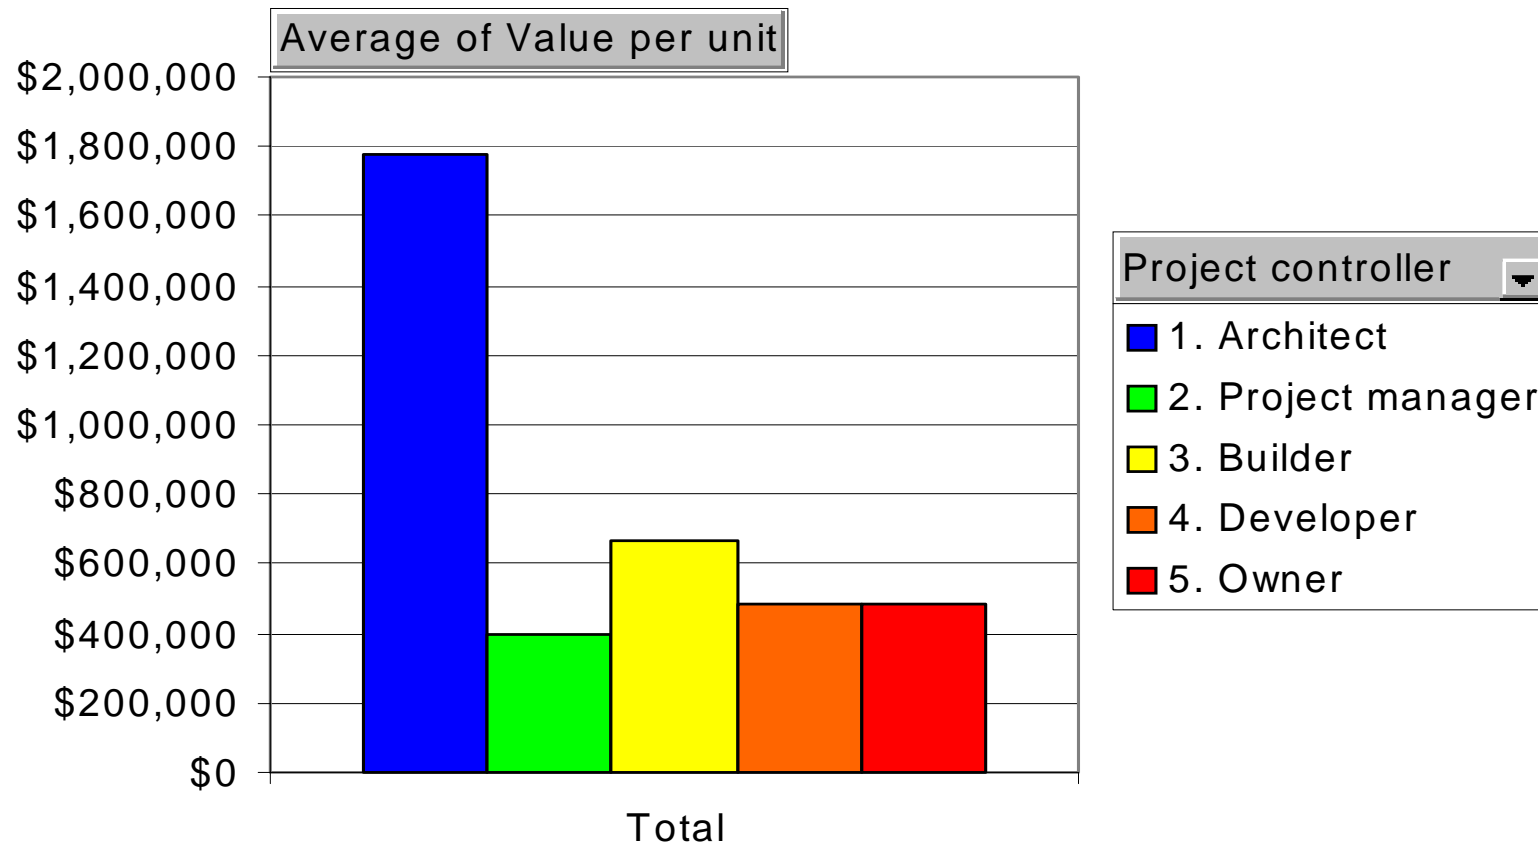
# Project Controller vs Value
